TEST CERTIFICATE

CERTIFICATE NUMBER	TC-F87.01
SPONSOR	Fire Rated Solutions Pty Ltd
DATE OF TEST	Wednesday 13 th October 2021
FULL TEST REPORT	TR-F87.01
TEST ID	FR144-S12

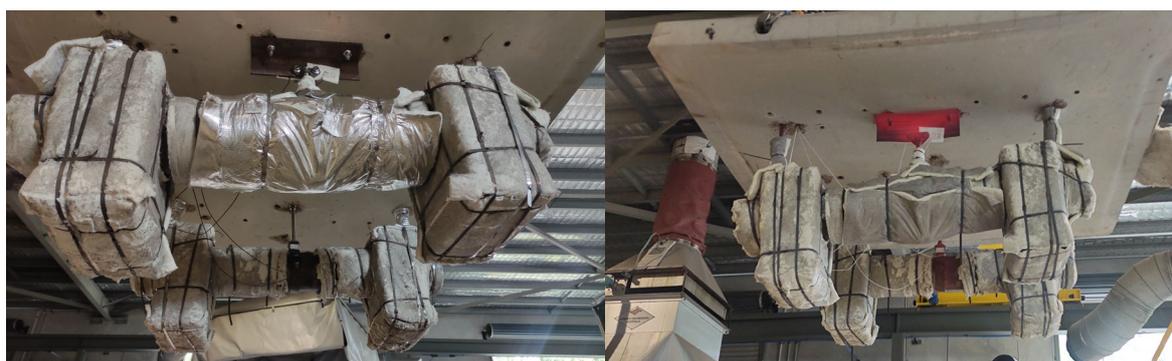
Pre (left) and Post (right) Test Photos:

TEST SUMMARY	
TEST SPECIMEN	Specimen A: FRS DN150 split bracket, M16 threaded rod, and FRS nut, Specimen B: FRS side bracket
DESCRIPTION	<p>Specimen A was suspended from the soffit of the slab by way off a single 310 stainless steel M16 diameter reverse-threaded rod. This threaded rod extended through the slab and was secured with a single 310 stainless steel nut located on the top side of the slab. Between the nut and the slab was a mild steel plate measuring 150 mm x 100 mm x 8 mm, this plate acted as a washer. Within the furnace, the threaded rod was secured to the split bracket by way of an FRS nut, the length of threaded rod within the furnace was approximately 200mm.</p> <p>Specimen B was a 100 mm x 75 mm x 6 mm steel angle was bolted though the slab using 2 x M12 304 stainless steel fixings and secured with two FRS nuts on the top side of the slab. Two FRS steel side brackets were installed to the steel angle using 2 x M12 304 stainless steel fixings and secured with two 304 stainless steel nuts. The bolts were installed on the south side of the angle and nuts on the north side. The south FRS bracket had a 304 stainless steel threaded rod down to the weight bar, the length of the rod was approximately 100 mm.</p> <p>The north FRS bracket was fastened to the slab by way of a 304 stainless steel M16 threaded rod, secured on the top side with a stainless-steel nut. Between the nut and the slab was a mild steel plate measuring 150 mm x 100 mm x 8 mm, this plate acted as a washer. The threaded rod was wrapped with an insulative wool type blanket.</p> <p>Through each pipe hanger bracket a nominally 1200 mm long x 165 mm diameter steel weight bar was installed. To each end of each bar, seven 300 mm wide x 400 mm high x 20 mm thick steel plates were added (totaling 14 plates on each specimen). The total weight was 424kg for A and 425.1kg for B.</p>

SPECIMEN	HEATING REGIME TO	DESIGN CAPACITY	TIME TO OPERATIONAL FAILURE	AVERAGE TEMP. AT FAILURE °C	MAX TEMP. AT FAILURE °C	MODE OF FAILURE
A	AS 1530.4	421 Kg	No Failure	No Failure. 500 °C @ 18 minutes	No Failure	-
	Structural Adequacy		No failure at 91 minutes			
	Integrity		Not applicable			
	Insulation		Not applicable			
For the purposes of the Building Code of Australia the Specimen A under test achieved a fire-resistance level (FRL) of: 90/-/-. The FRL is applicable to the specimen as tested and exposed to fire from the same side as tested unless the specimen is symmetrical in which case fire exposure may be from either direction.						
B	AS 1530.4	421 Kg	No failure	No Failure 500 °C @ 13 minutes	No Failure	-
	Structural Adequacy		No failure at 91 minutes			
	Integrity		Not applicable			
	Insulation		Not applicable			
For the purposes of the Building Code of Australia the specimen under test achieved a fire-resistance level (FRL) of: 90/-/-. The FRL is applicable to the specimen as tested and exposed to fire from the same side as tested unless the specimen is symmetrical in which case fire exposure may be from either direction.
